# LAKE OF THE WOODS COUNTY

## QUOTE FORM

Scope of work: Slope Failure Repair  
 Location: JD 28 See attached map for location.

JUDICIAL DITCH 28

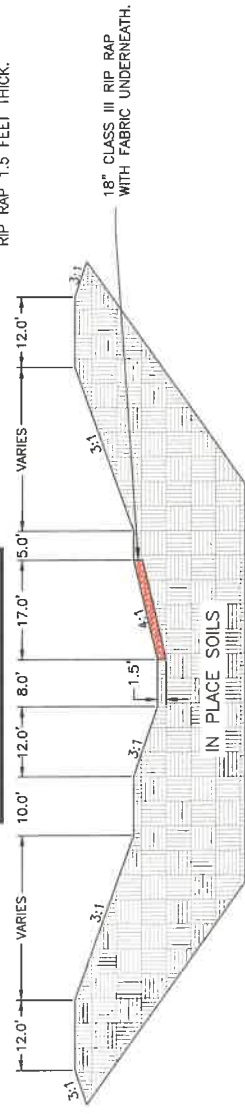
## PROPOSED CORRECTIVE ACTION

EXCAVATE DITCH SLOPE TO REMOVE SLIP-PLANE. PLACE QUARRY RUN RIP RAP 1.5 FEET THICK.

- Slope Failure Repair will consist of creating a new slope by excavating into the bench area and installing riprap. This slope may vary from 3:1 - 4:1 depending on the erosion severity. The contractor shall compact this prior to placing fabric and riprap on the slope.

- Installation of a MnDOT Type 4 (felt style) fabric underneath the riprap is considered incidental to the Class III riprap.
- Dimensions of work will be determined in the field prior to construction as directed by the Engineer.

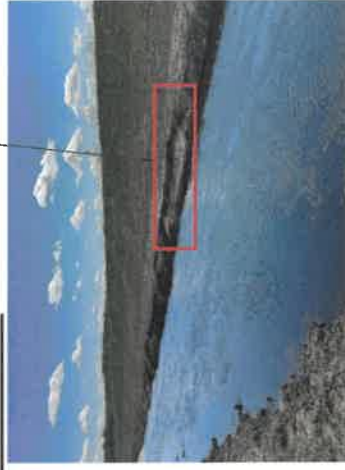
DAMAGED AREA
